USING HIGH PERFORMANCE CEMENTITIOUS FOR REPAIR COLUMNS

Abstract— To restore the structural capacity of the distressed elements, retrofitting and/or strengthening are needed. Laboratory investigation was undertaken to develop high-performance cement-based grouts/cementitious composites that makes them ideally suited for structural repair. An experimental program was conducted where nine circular reinforced concrete columns were tested with varying material types and repair location (cover only – cover extended to core) – one as control, four contained various material types throughout the cross-section and four contained repair material only in the outer concrete. All nine columns were tested by the application of a concentric, axial compression force. Another nine columns with the same repair techniques were tested subjected to eccentric loads. It was found that ductility of the columns with a silica fume or fibers contained in repair material proved to be more ductile. Placing the repair material at cover through the steel reinforcement into core increased the load capacity compared with cover only. Using Silica fume or fibers in the repair material at cover through the steel rei

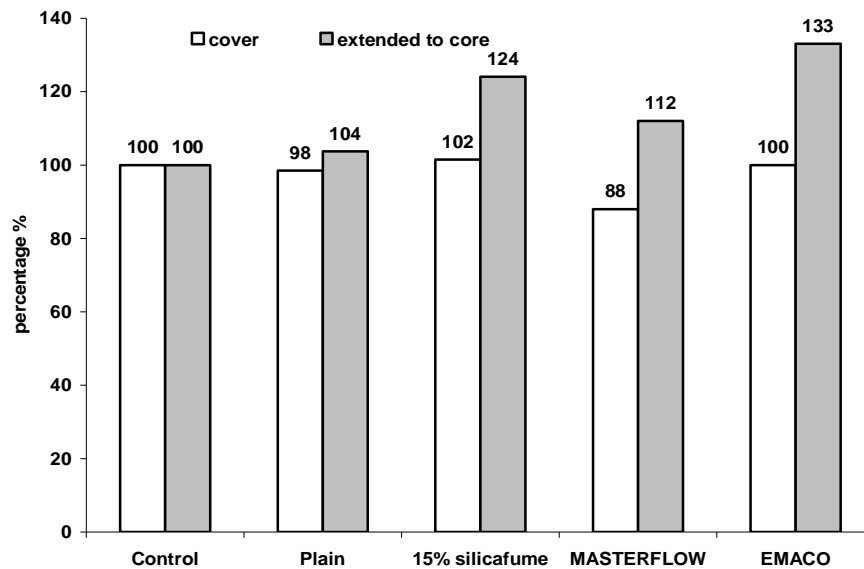
Fig. 12 Effect repair material types on ultimate concentric load, compared with control column

In order to assess the benefits of varying the location of the repair material, all columns were compared. As can be seen in Fig. 12, columns repair in cover extending through the region of the steel reinforcement into the core gave a higher load than those repair at cover only. Emaco as a repair material gave a higher load capacity than control column (without repair C01) by 33%. Silicafume added to repair material (C03, C04) gave a higher load capacity by 4, 24% respectively, compared with control column (without repair). Grout (Masterflow) gave a load capacity slightly higher than control column (C01) by 12% at repair case up to core. On the contrary, grout gave a load capacity lower than control column (C01) by 12% at only cover location. It was concluded that grout are not adequate as a repair material, especially at location in cover only. Columns Approximately, C02 and C03 gave a same load capacity compared with control column C01. As shown in Fig. 12, It was concluded that Emaco (mortar with fiber) or mortar with silicafume can be used as strengthening and repairing material, especially at the location in cover extending into the core.

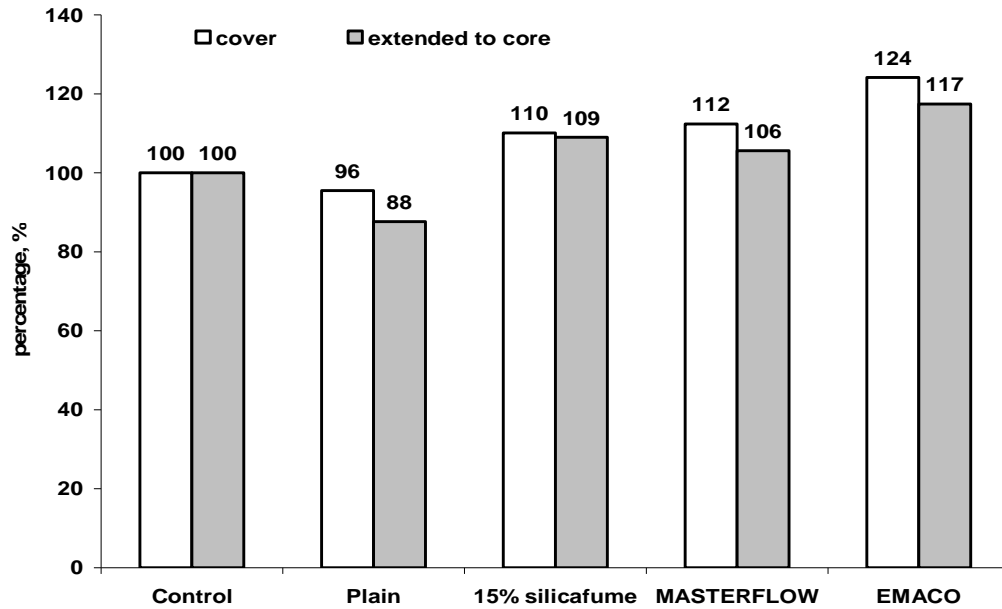
Fig 13 Effect repair material types on ultimate eccentric load, compared with control column

Compared to the repair material type for columns tested under eccentricity load, loads were observed at the tests as shown in Fig. 13. The eccentrically loaded columns were compared, as well as the concentrically-loaded column. The testing results indicated that Emaco as repair material is more effective as a material repair compared to other material repair. This proved because the presence of fibers has a significant influence on the behavior of eccentrically loaded columns. The comparison among the eccentrically columns show that all material excluding plain mix (mix1) achieve a good result to increased ultimate load by 5% - 24%, compared with control columns. There is no significant effect between the location of repairing (cover only – cover extended to core). NSC as a material repair can not be restore the integrity of a repair column at eccentricity case.
